OHIO RIVER BASIN
GLADE RUN
BUTLER COUNTY,

NDI No. PA 01071

National Dam Inspection
Program. GLADE RUN DAM.

PHASE I INSPECTION REPORT.

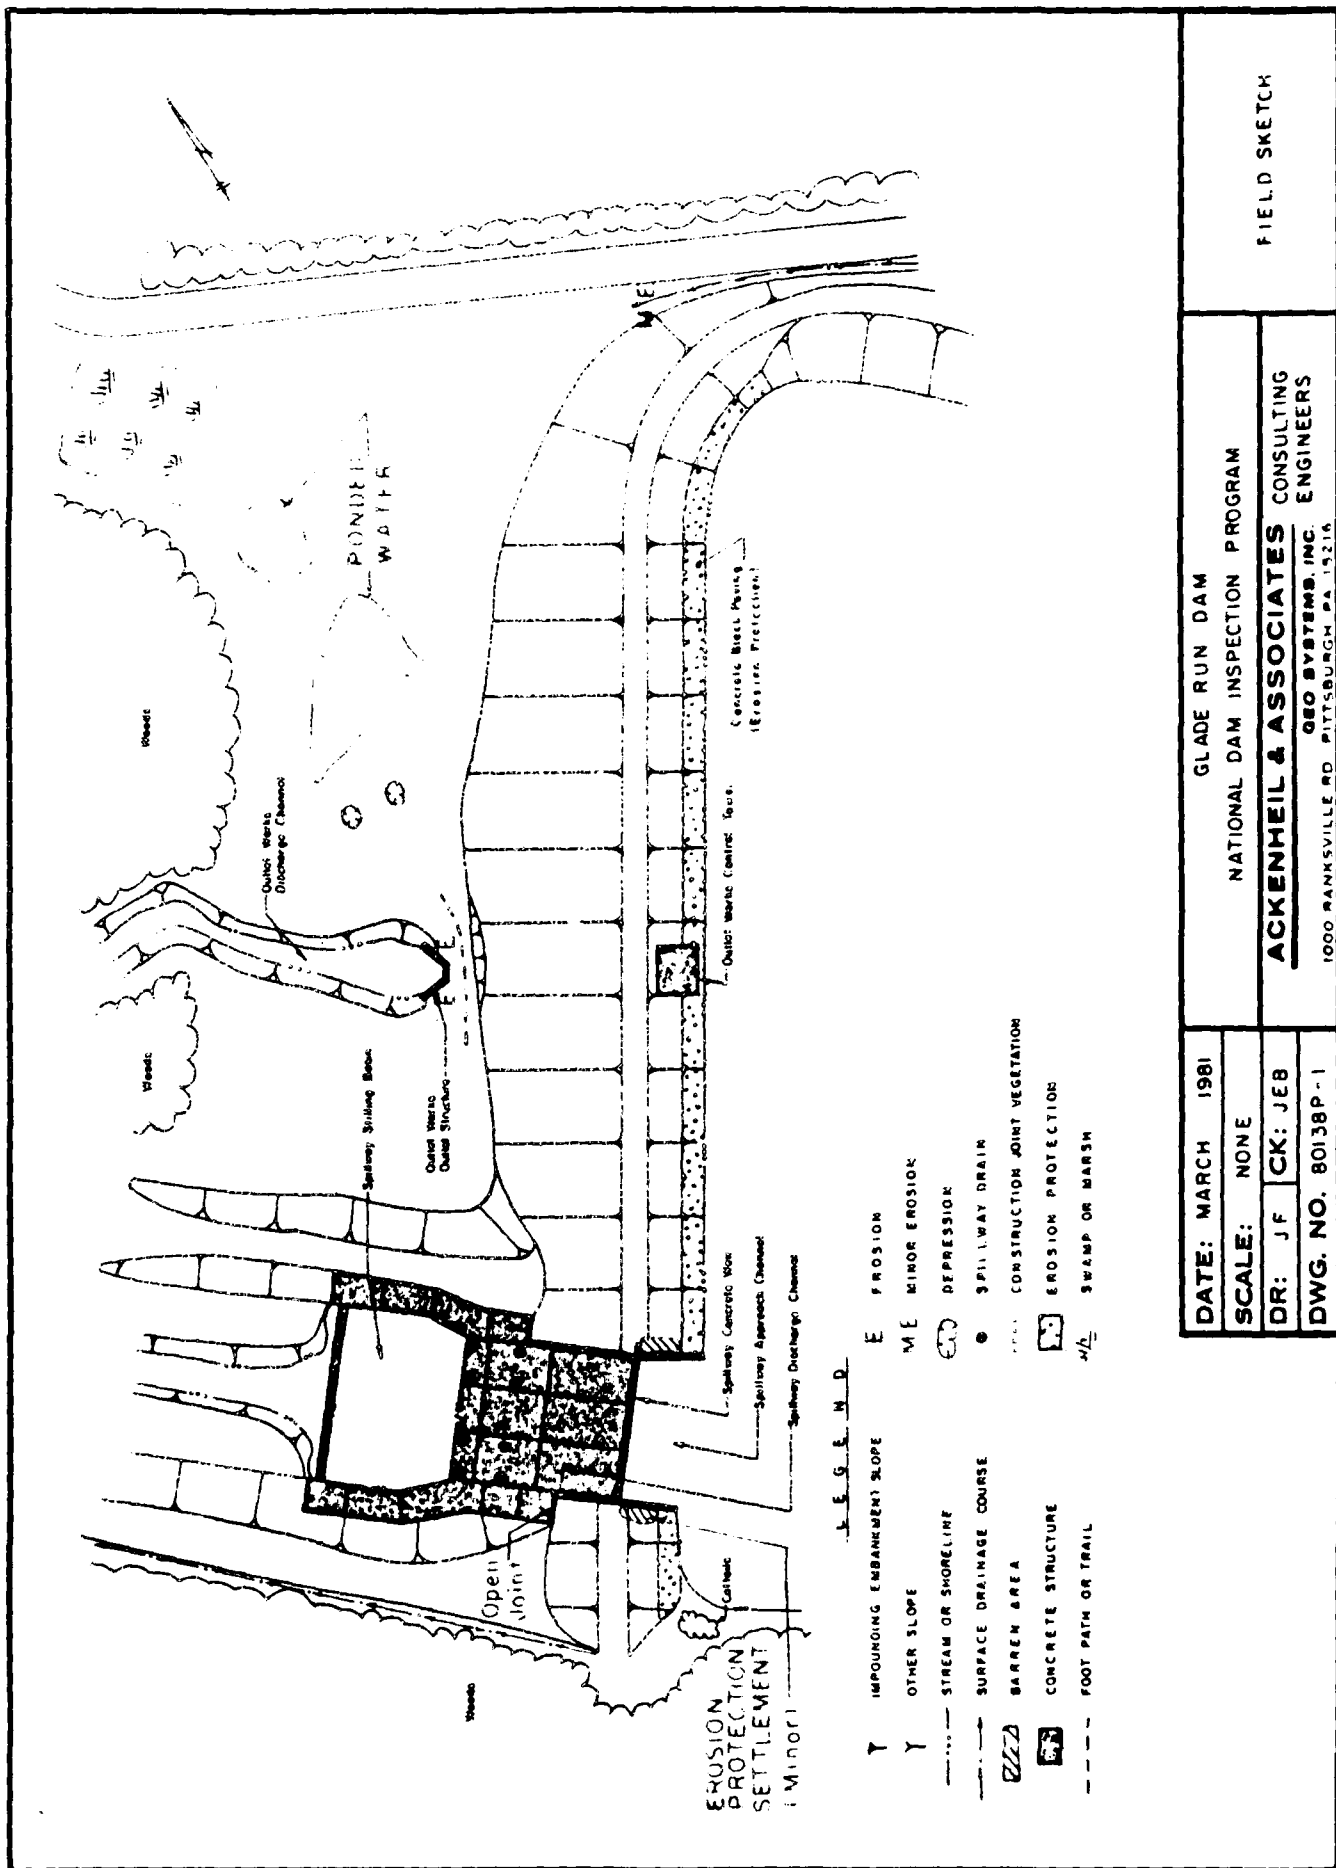
DATE: MARCH 1981		GLADE RUN DAM		FIELD SKETCH
SCALE: NONE		NATIONAL DAM INSPECTION PROGRAM		
DR: JF		ACKENHEIL & ASSOCIATES		
CK: JEB		CONSULTING ENGINEERS		
DWG. NO. 80138P-1		QEO SYSTEMS, INC. 1000 RANKSVILLE RD PITTSBURGH PA 15216

Minor settlement of the erosion protection was noted immediately to the left of the spillway's left training wall.

Two small depressions were noted on the floodplain just below the central portion of the toe of the embankment. Neither depression appeared to be in an active state of enlargement.

(3) Repair of the minor settlement in the concrete block pavement near the left spillway training wall.
